**Our reference: FTC 18/231**

## **SANS 10177 – PART 2 TEST RESULTS FOR THE SOLID FIRE RATED DRYWALL SYSTEM**

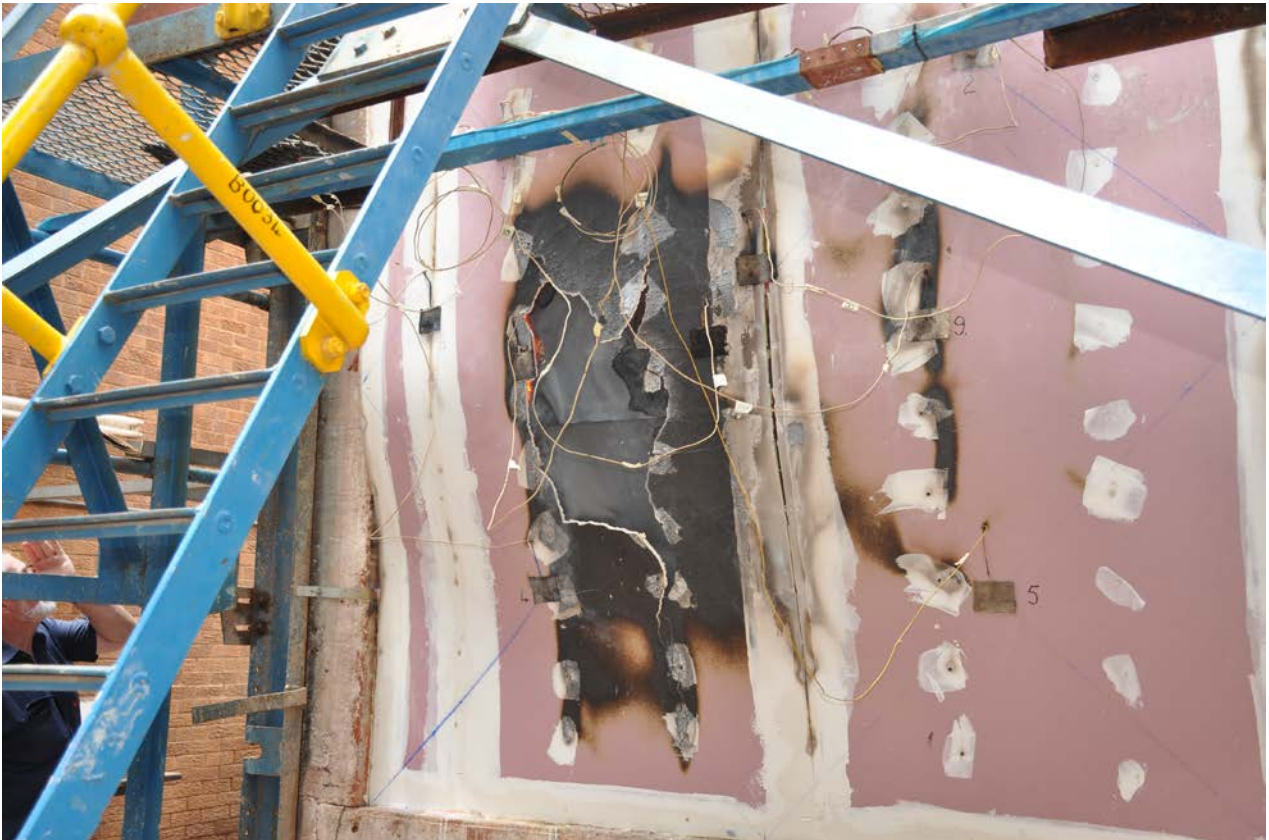
1. The **Solid Fire Rated Drywall System** was tested using the **SANS 10177 – 2** test protocol on the 30<sup>th</sup> of January 2019.
2. The panel exhibited minimal smoke and steam release for the first hour of the test, thereafter the panel quickly deteriorated. TC 8, a joint thermocouple, exceeded the maximum allowed temperature for a single thermocouple (205 °C) at 1 hour, 15 minutes and 5 seconds. This is considered a failure of the **Insulation** criterion.

3. At approximately 1 hour, 18 minutes and 45 seconds the right hand side joint split open. This caused the system to severely deflect outward, compromising both **Stability** and **Integrity** of the system.

Figure 1.1: The unexposed side of the system after the test conclusion

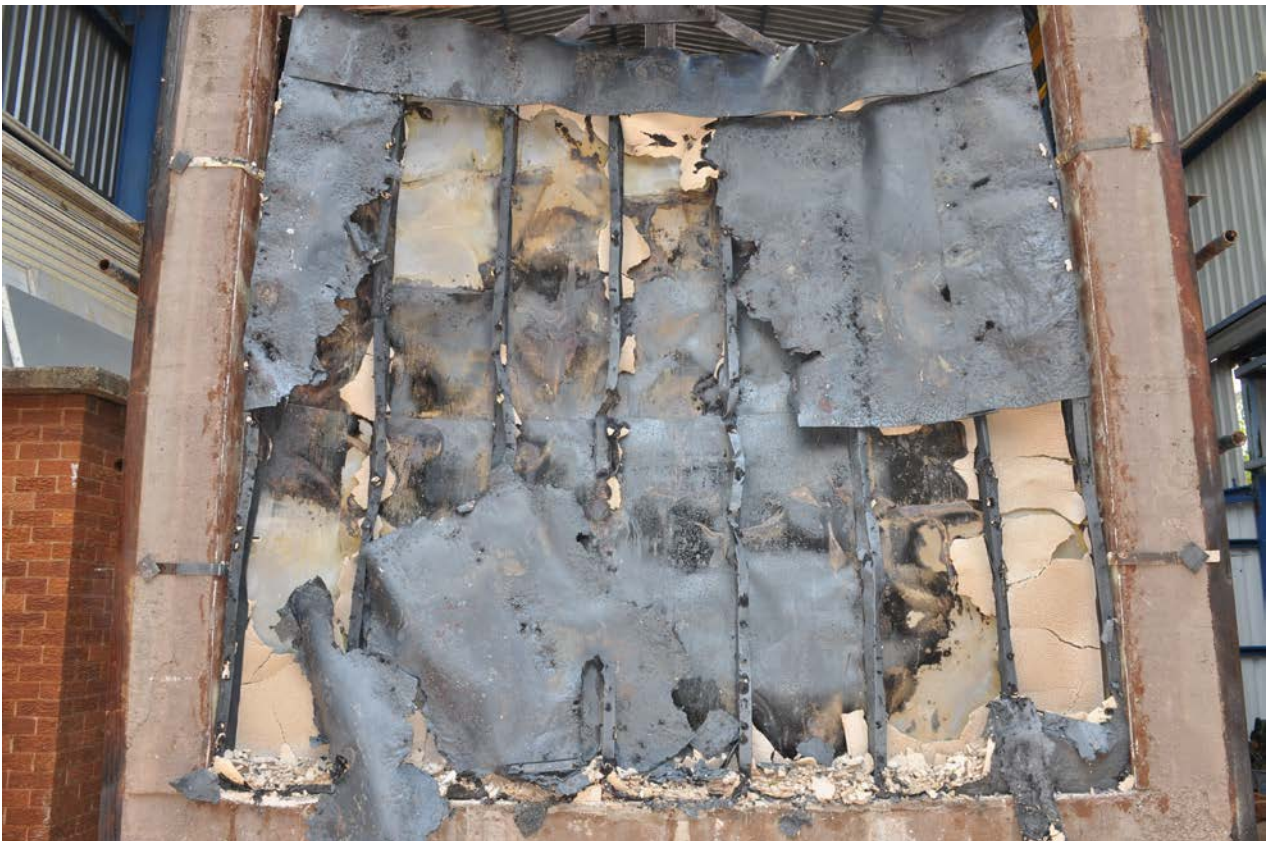
4. Gypsum fire boards from an unknown foreign manufacturer were used in the construction of this system. Post-test the boards were examined and found to have a reinforcement mat, orientated longitudinally and horizontally. Typical fire boards usually have randomly oriented fibers in the plaster mix.

Figure 1.2: The exposed side of the system after the test conclusion

Due to premature board failure on the exposed side, the system temperature rose rapidly after approximately 1 hour and 10 minutes. This can be seen by the intermediate steel plate degradation on the exposed side of the system. Using a better quality fire board will greatly increase the fire performance by protecting the system.
